# BROADMEAD ROAD VIADUCT

## Concrete Condition Assessment -Test Result Interpretation Report

BRVTP-ATK-SBR-B4-RP-CB-000005

October 2024

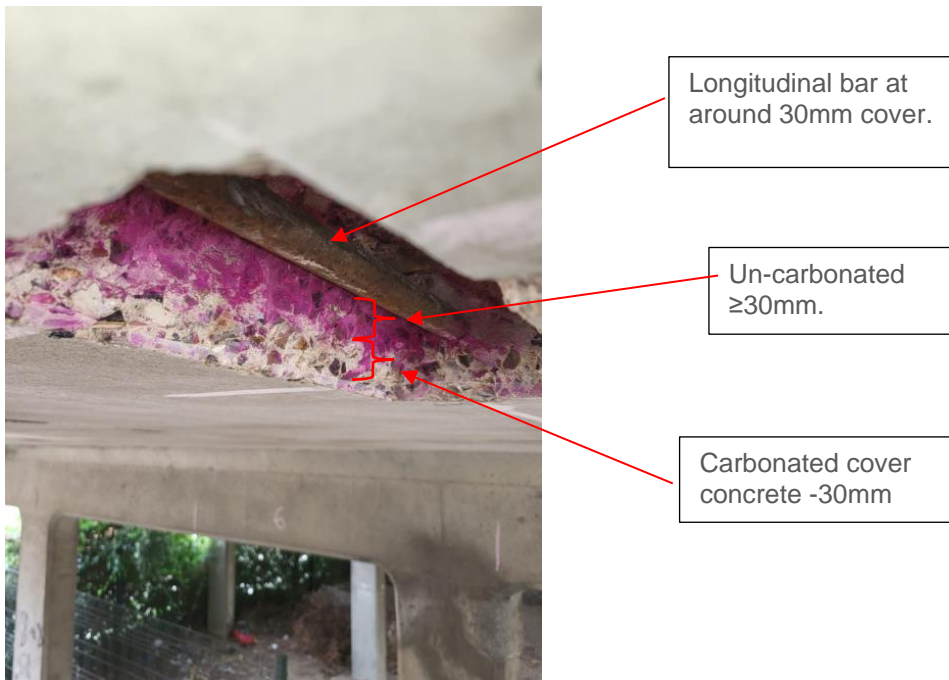
- The intermediate piers were typically in good condition with only a small number of visible defects.
- The deck soffit condition was variable, with large patches of delamination and or poor compaction previously removed, and patch repaired. The deck soffit away from these areas looked to be in fair condition. The testing subsequently proved that the deck soffit concrete was heavily carbonated (See Figure 1).

Figure 1- Carbonated concrete on deck soffit- Location TS1.

- **Deck Soffit-** Visual inspection confirmed the soffit was in varied condition with a wide range from poor to good. Numerous defective areas were evident with multiple previous repairs the quality of which are also highly variable. Despite numerous other areas of the deck soffit appearing in fair to good condition the testing indicated an ongoing risk to the elements from carbonation. Testing indicated extensive deep carbonation on the deck soffit which presents a high future corrosion risk, and measures should be put in place to mitigate this in the form an ICCP system. Application of anti-carbonation coating at this time would not be effective as the majority of areas already show the carbonation front is at the level of the reinforcement.

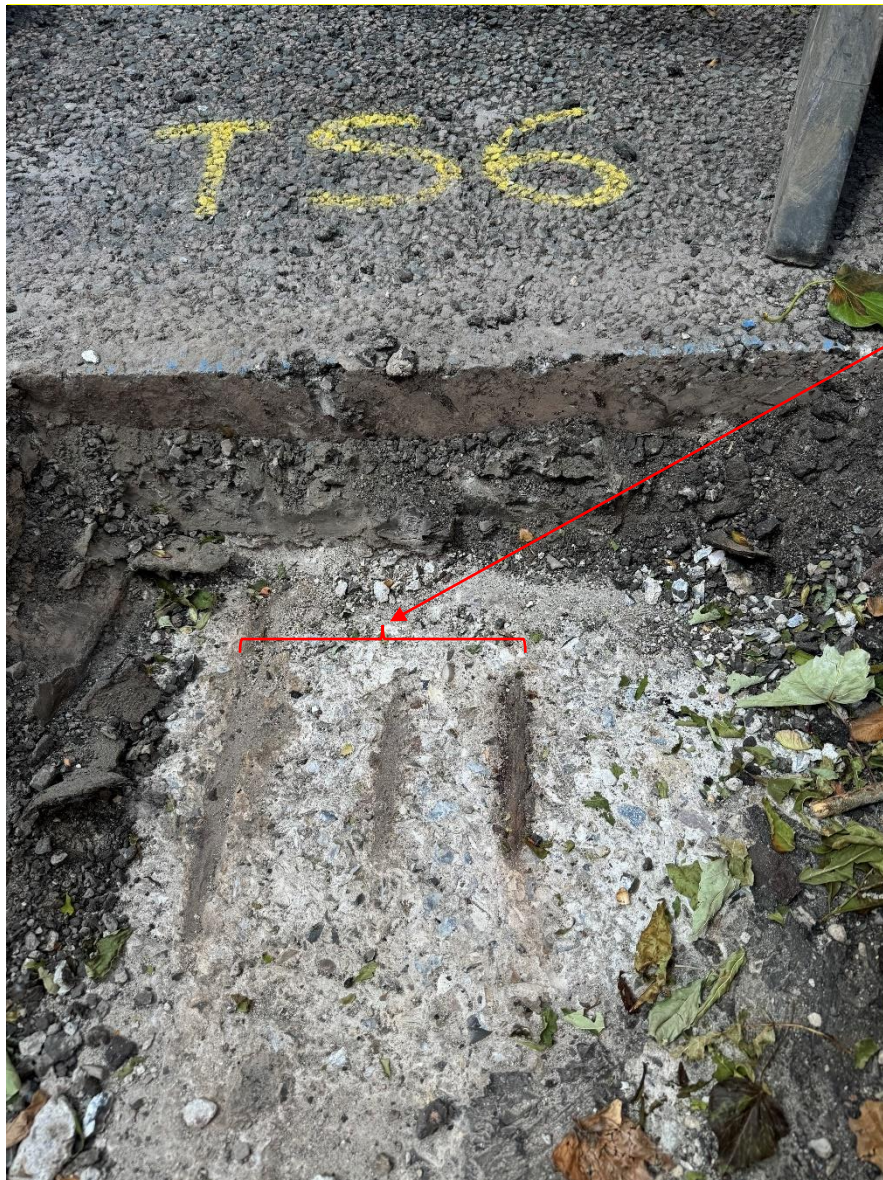
Corroded low cover bars. Top of bars are flat-possibly from historic planning operation.

Figure 2- Corroded bars with section loss, possibly due to historic planning, on deck topside -location TS6.

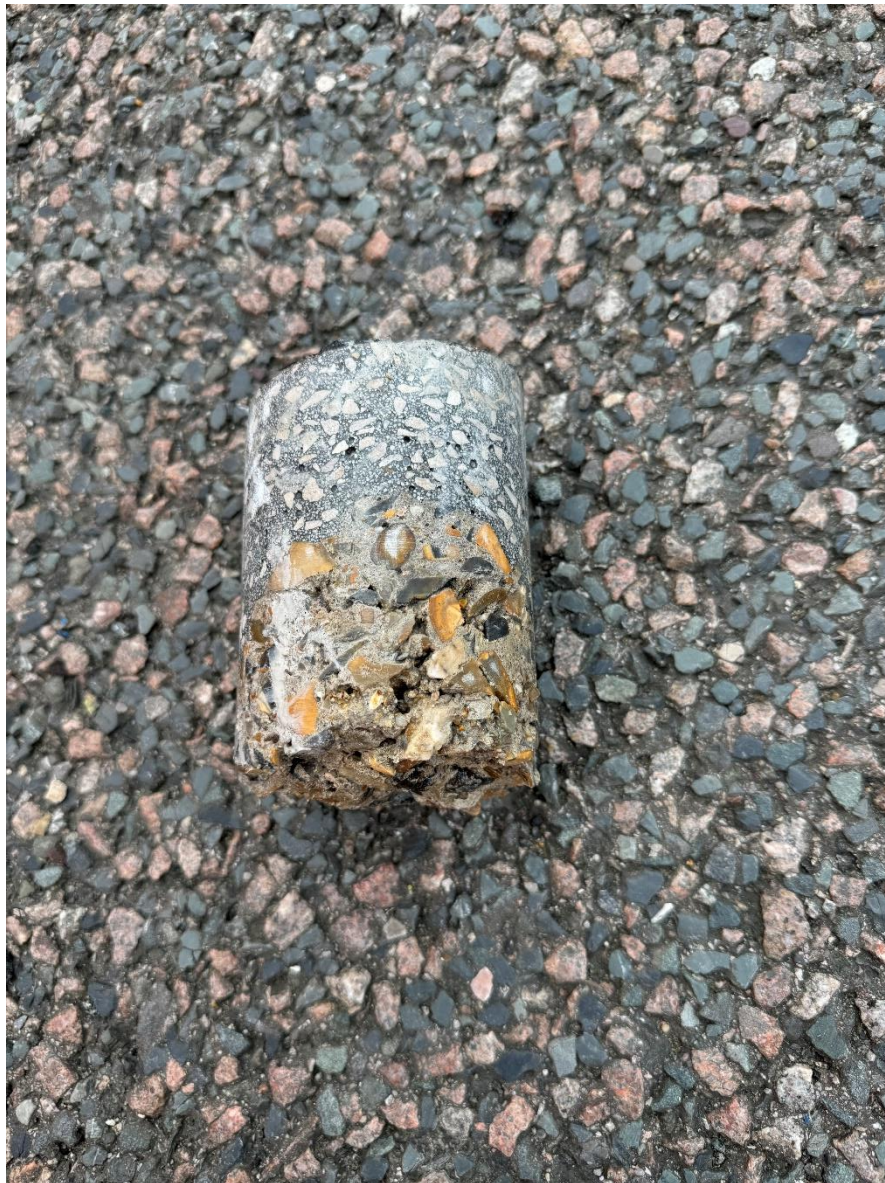
- The deck topside was only visible at the trial pit locations opened for the concrete testing. Within these areas the condition was again variable with some areas exhibiting low cover and spalling once the waterproofing was removed. It was clear that previous concrete repair phases had been undertaken on the deck topside. The report states that generally the bar condition within the breakouts was sound, however one of the extended breakouts for tensile strength testing exhibited section loss to 3No. low cover bars that had not been part of any previous repairs (See Figure 2). An aborted core sample also revealed that a concrete repair had not fully removed the defective concrete with poorly compacted parent material below the repair (See Figure 3).

Figure 3- Core from deck topside showing poorly compacted parent concrete below repair.

- **Deck topside-** fair condition from trial pits/testing locations but some defects are highly likely elsewhere on the deck topside. Repairs, appear to have been carried out to a fair standard; however, a core sampling into one of the repair areas indicated poorly compacted parent concrete below the repair suggesting that previous repairs have not fully addressed the defects within the slab. A proper understanding of condition can only be assessed once surfacing and waterproofing have been removed and the concrete hammer tapped for delamination.

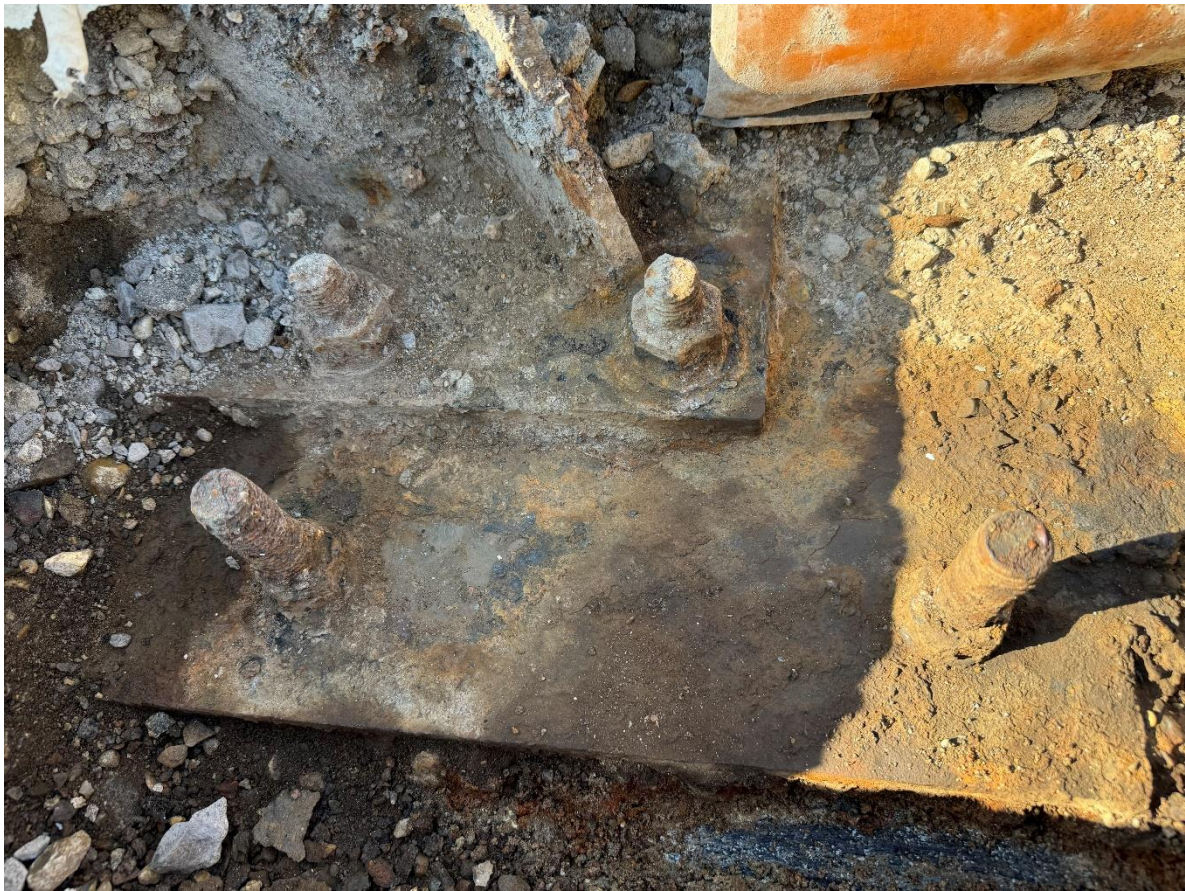
- The investigation of the lamp column fixings was also not completed due to time constraints, with only the corroded top plates partially exposed. The bolt condition and the presence of any section loss was not confirmed (See Figure 4). However, given the condition of the top plates coupled with deterioration around many of the bolt fixings on the deck soffit the lamp column holding down bolts should be assumed to be in poor condition.

Figure 4- Corroded base for lamp column in Span 4- bolt not extracted

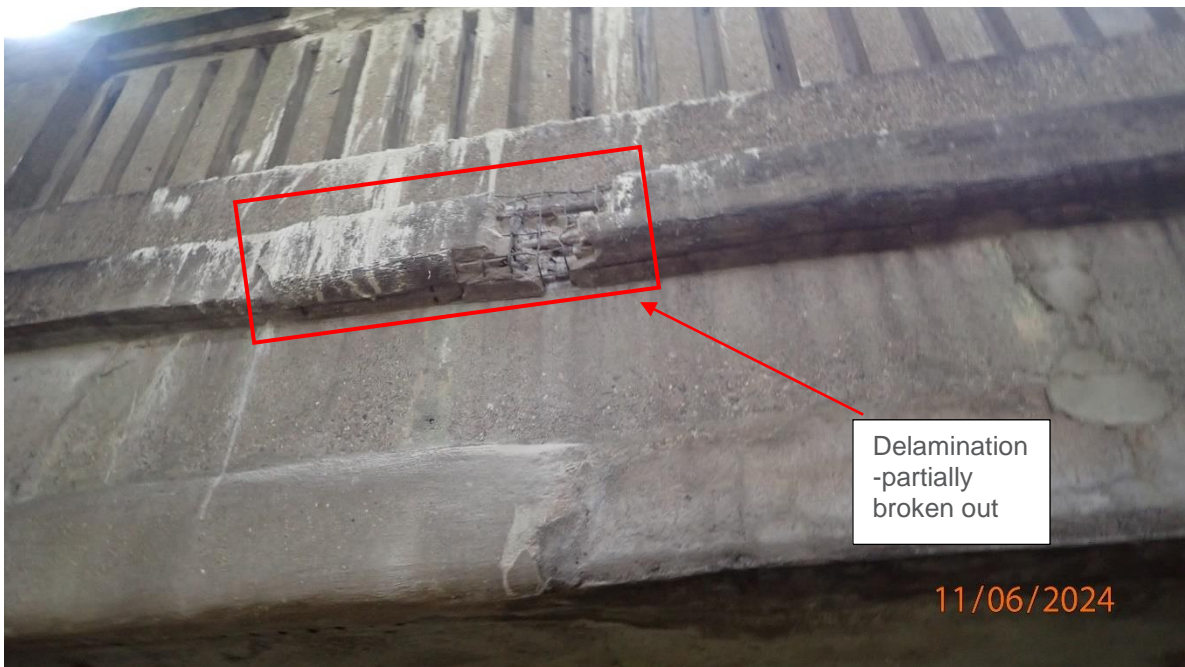
- The parapet and edge beams were in variable condition, with frequent previous repairs particularly to the edge beams. The test report states no defects for these elements which is not considered entirely accurate- See Figure 5 for an example defect.

Figure 5 -Defect on parapet at northwest end

- Parapet -The parapet exhibited defects in places, with the testing report again stating no defects were evident which is not considered accurate; however, it should be noted that the test panels were confined to the base of the parapet directly above the edge beam. Taking into account the nature of the element it may be beneficial to focus on any necessary concrete repairs as required with a monitoring regime to address any on-going issues. If the corrosion risk is seen as being too high, then the parapet would require replacement.
