Appendix A: Local Heritage List Buildings and Structures

London Borough of
Redbridge

March 2023

Client: London Borough of Redbridge
Project Number: F2430

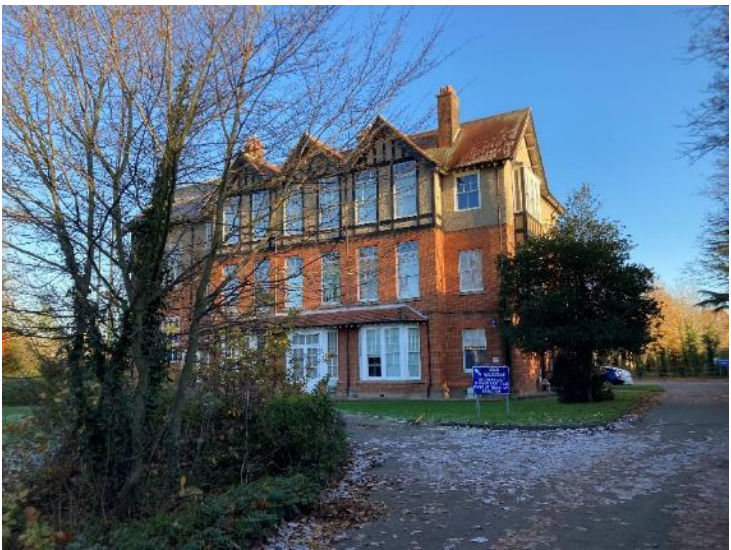
7. Description				
<p>1903 three storey building, Pevsner states that the building was the 'entrance house' to the Barnado's Girls' Village. Arts and Craft style. Constructed of red brick with pebble dash render at second floor. Six bays. Three central bays have bay windows at ground floor level with hipped, clay tiled roof above, and at first and second floor level there are 6 over 2 sash windows (six on each floor) with small casement windows above. Three gables sit above the sash windows with decorative timber framed patterns. Clay tiled roof with three chimney stacks.</p>

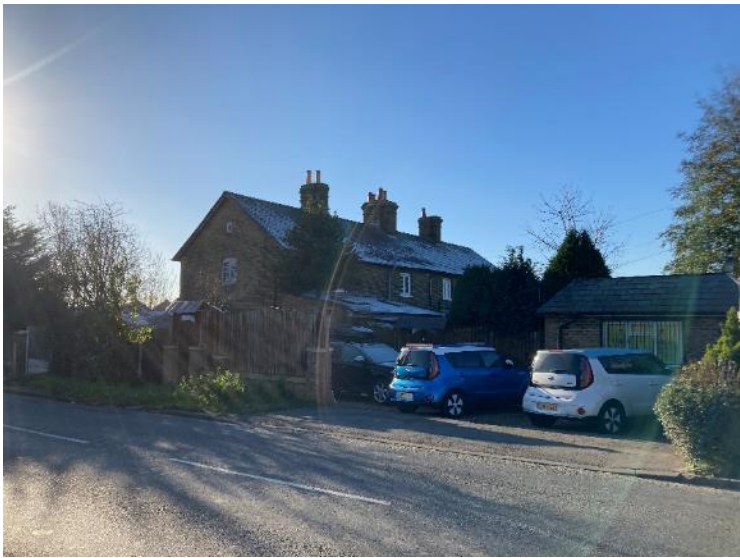
7. Description				
<p><u>Farm House</u>: 1855. Two storey on L-plan. Brown stocks with red brick projecting quoins, string course and cornice. Medium pitch hipped slate roof. Double hung sash windows with glazing bars and/or segmental gauged red brick arches. South wing, three windows but two ground floor windows insensitively replaced. East end of south wing has recessed entrance with semi-circular gauged red brick arch, half glazed door and fanlight. One window over. Projecting chimney with plaque 'VR 1855'. East wing continues with five windows.</p> <p><u>Farm Buildings</u>: 1855. North-west of farmhouse. Enclosed large square farmyard. Two storey barns on north and south, one storey barn on west. Stock brick, medium pitched gabled slate roofs. Two storey barns have timber pivot windows with glazing bars. Ground floor partly open with Cast Iron columns and timber beams. One storey barn has timber louvred ridge vents. An impressive and rare (on this scale) group of nineteenth century farm buildings.</p> <p><u>House at Entrance</u>: 1855. Two storey. Stock brick. Gabled slate roof. Two windows first floor. Central entrance with projecting porch and one window to ground floor. Rendered East gable wall. Plaque "VR 1855".</p> <p><u>Farm Workers Cottages</u>: Mid nineteenth century. Terrace of four. Yellow stocks with steep pitch slate roof. Each unit has two windows to first floor, one window and original solid door to ground floor. Single hung sashes with glazing bars under segmental arches.</p>

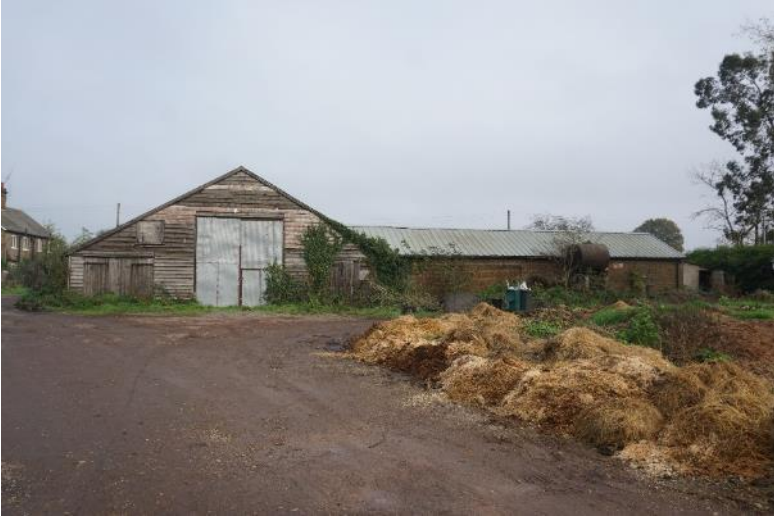
7. Description			
Built during the mid-nineteenth century. Range of barns with a U-shaped platform. Range on the east-west axis of a low gable form with wide footprint, weatherboarded. Ranges on north-south axis single storey in stock brick. Interior not inspected.

10. Aesthetic / Architectural Value							
It is notable for its appearance and detailing typical of mid-nineteenth century agricultural buildings, contributing positively to local style. The roofs have been replaced with modern materials but its character is unaffected.

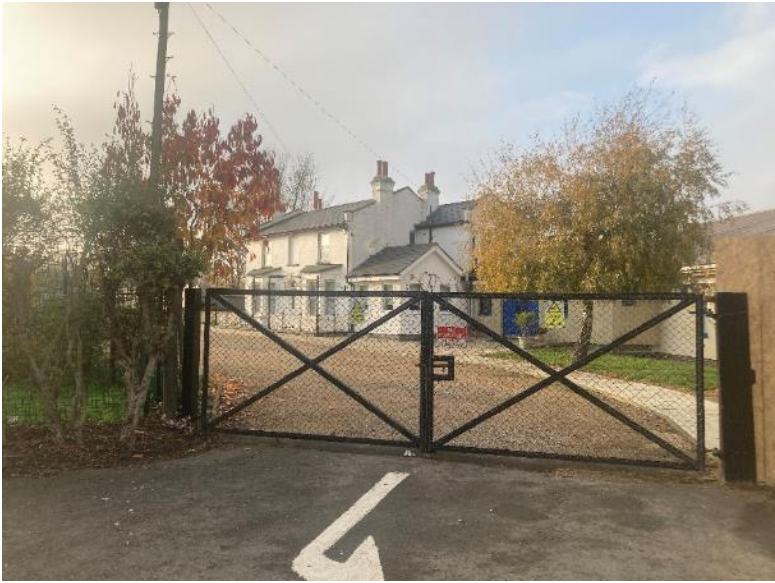
7. Description
Constructed c.1860, replacing an earlier building. A two-storey brick built property (now painted white) under a slate gabled ended roof with four chimneys to flanks. Central entrance flanked by two canted bays. Windows are of sash proportions with blank first-floor central window. Extended significantly to the north-east. An iron work veranda on the southern elevation.

10. Aesthetic / Architectural Value							
The dominant, modern extensions to east do not respond positively to architectural context and scale of the original property. However, the original scale, form and appearance farmhouse remains appreciable. A side from the modern extension and window replacements the original dwelling has maintained architectural details and character.

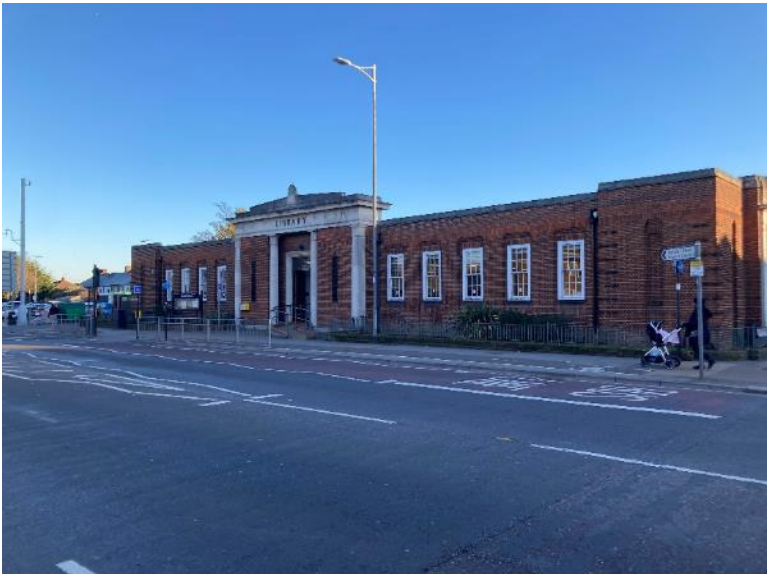
7. Description
1938 designed by L.E.J Reynolds, Borough Surveyor. Library. Single storey building, steel frame with red brick façade. At the centre of the front elevation is the entrance with Corinthian type columns either side, constructed of Bath stone, with architrave above and pediment a top. Five six over six sash windows either side. Impressive side entrance on west side

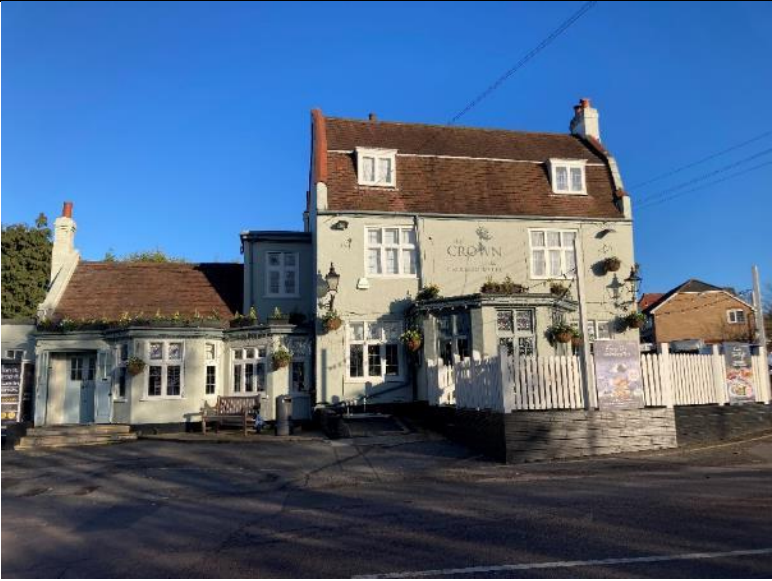
7. Description
Eighteenth century, altered. Two storeys. Two windows wide. Colour washed brick work. Plain tile mansard roof with eaves gutter and two dormers. Double gables two storey rear extension. Single storey splayed bay at front with flat roof and heavy fascia. Modern timber windows, heavy section, side hung sashes with leaded lights. Two storey projection and one storey extension on north with gable roofs in plain tiles. A prominent building in the Conservation Area.

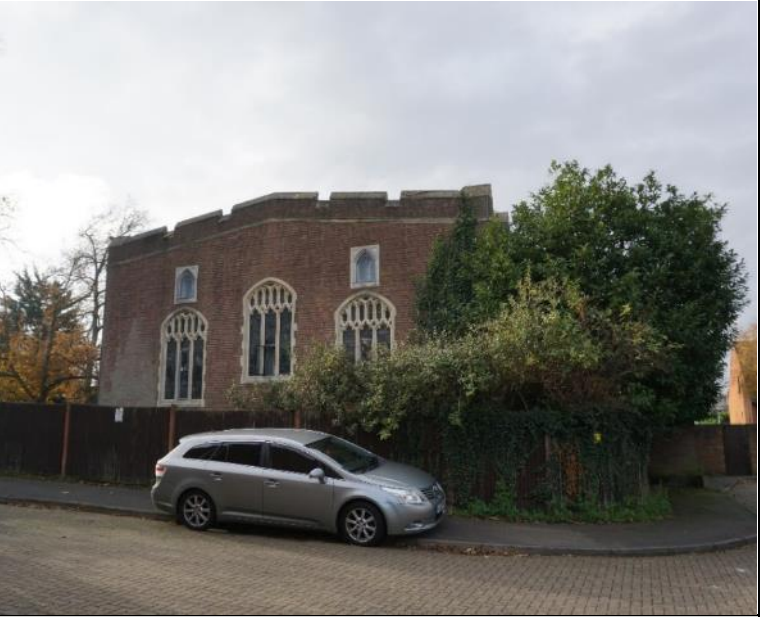
7. Description
Former chapel, constructed in 1932 and designed by W. H. Godfrey. Constructed from red/brown brick with a simple rectangular plan. Features include stone dressing, windows with perpendicular tracery and prominent flying buttresses.

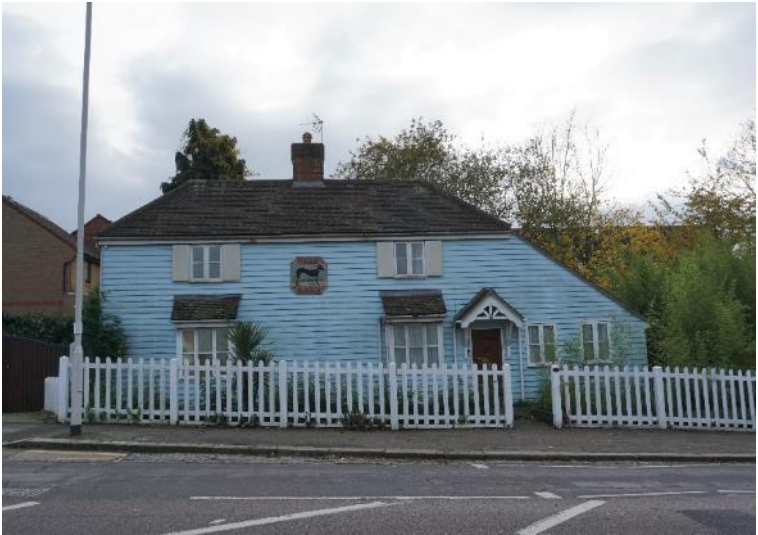
7. Description
Eighteenth century cottage, formerly a semi-detached pair now a single dwelling. Timber framed and weather boarded under a hipped tiled roof and catslide to the west. The front elevation has two small bay windows to ground floor and small casement windows to first floor. Sign centrally located reading 'The Cottages' with an image of a greyhound.

10. Aesthetic / Architectural Value							
Scale, form and appearance present an eighteenth-century cottage character. The property is indicative of the area's earlier development phase and contrasts positively with the surrounding development which predominantly derives from the twentieth century. The windows appear to be replacements but are sympathetic to the architectural context of the property and the boundary treatment (white picket fence) is also in keeping with the dwelling.

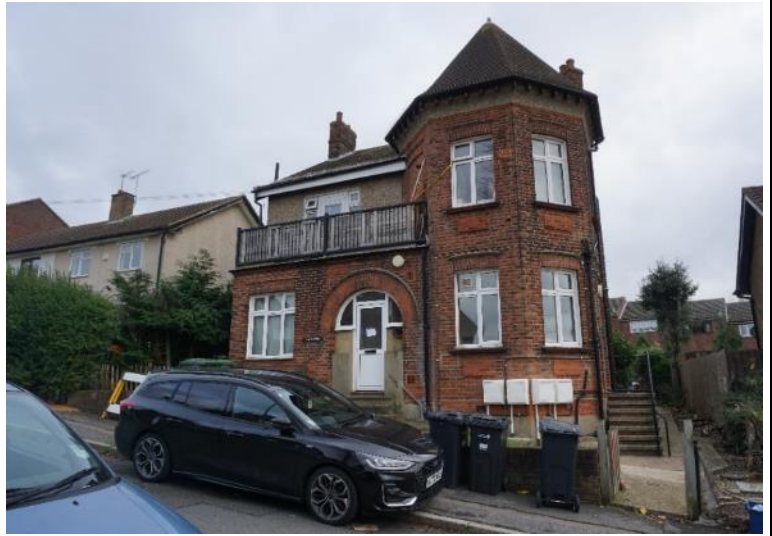
7. Description
Large Edwardian house built around 1903, constructed from redbrick. The property is two-storeys in height under a plain tiled gabled ended roof which is flanked by red brick chimneys. First floor has pebble dashed render with half timbering effect. Style displays a distinct turret element round arched entrance door, exposed rafters and balcony with metal balustrade. All of which were refinements of earlier Victorian decorative features.

10. Aesthetic / Architectural Value							
The property is typical Edwardian dwelling with attractive features such as the turret, terracotta tiles, prominent chimneys and exposed rafters. The property has been altered including replacement uPVC windows and doors, infill porch, pebble dash render and replacement roof. All of which erodes the original character of the property.

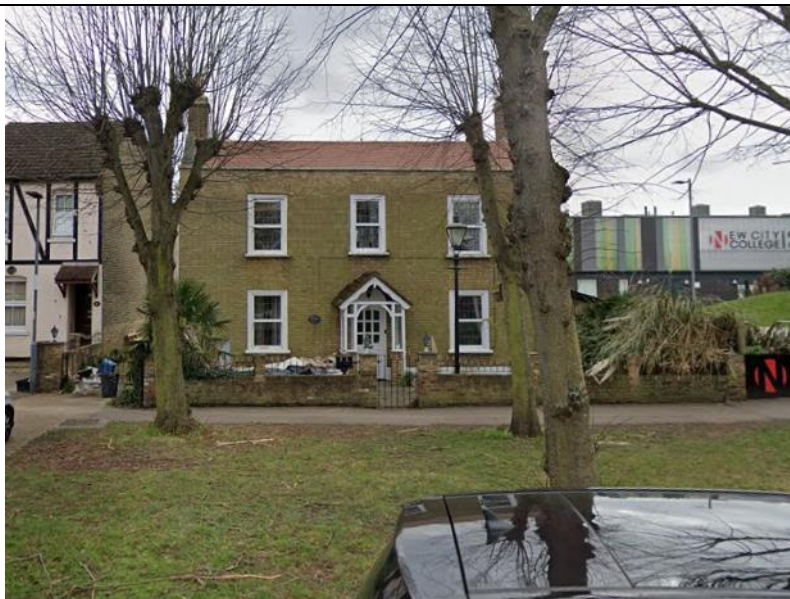
7. Description
Detached dwelling constructed from buff stock brick in the late eighteenth century. The property is set over two storeys with a central entrance with a block semi-circular fanlight. The property sits under a gabled roof with catslide to the rear. The roof is covered in machine made clay tiles and is flanked by two chimneys. A single storey lean-to extension on the west elevation and an ancillary range extends from the southwest corner of the property. Both are constructed from stock brick with slate roof covering.

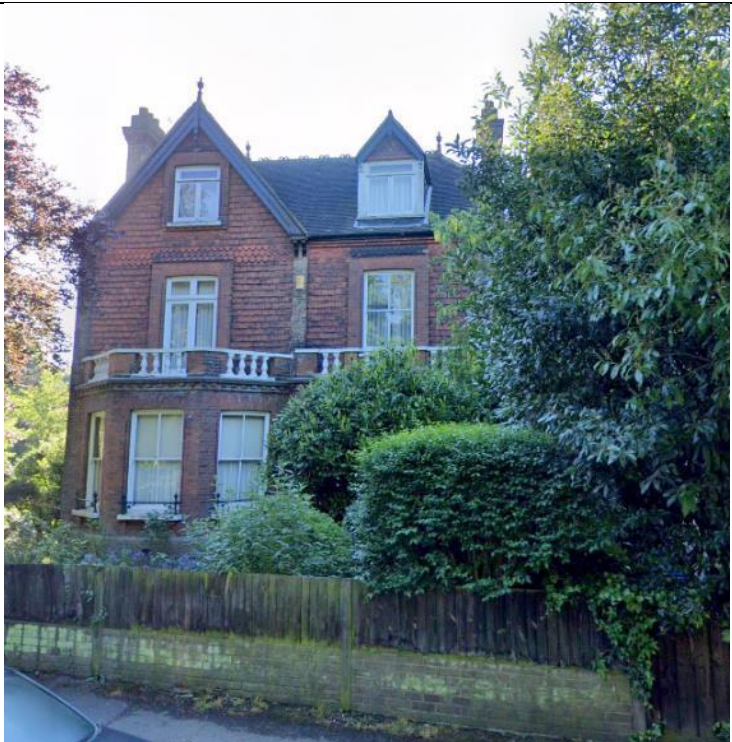
7. Description
Built circa 1883. The property is detached and set over two storeys with attic. Constructed from buff stock brick with red brick to window surrounds and bay windows. Timber sash and casement windows, ground floor bay windows have cast iron window boxes. Scalloped and straight tile hanging to first floor. The bays to the front elevation have stone balustrading. Hipped roof with projecting gable elements and dormers which have finials, the roof is covered in clay tiles with crested ridges and flanked by chimneys. Entrance off Higham Road with a canopy supported by timber brackets.

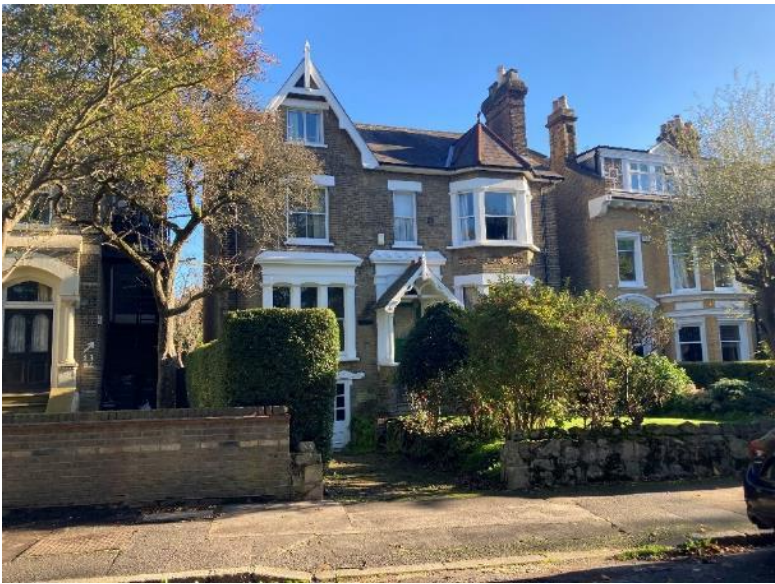
7. Description
<p>Built circa 1883. The property is detached and arranged over two and a half storeys with basement level. The property is constructed in buff stock brick under a gable end roof covered in slate. The roof is flanked by large chimneys with corbelled detail. Central entrance with Tuscan portico and gabled canopy accessed up steps. Entrance flanked by full height canted bay to the right and gable to the left with decorative barge board and finial. Timber sash windows with stone surrounds.</p> <p>On left hand in basement at foot of ramp is a coach house, a Victorian antecedent for an integral garage, and a rare and interesting feature.</p>

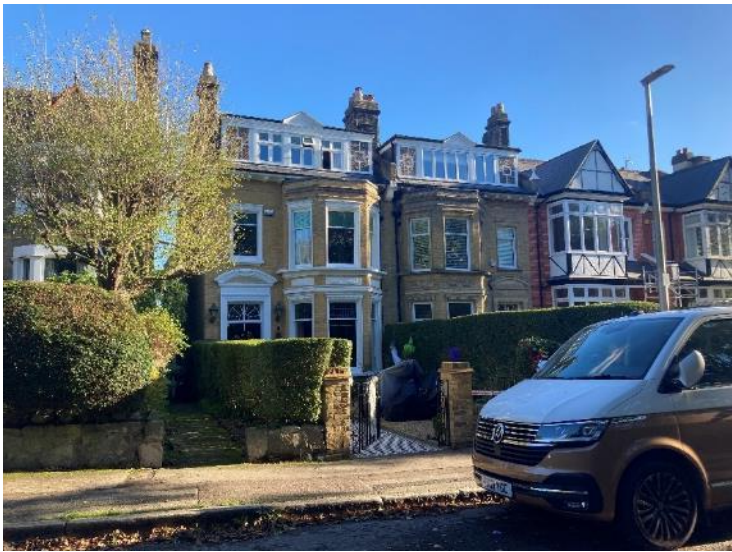
7. Description
Built circa 1889. The semi-detached pair are set over two storeys with attic level. Constructed from yellow stock brick under a gable ended roof covered in slate, the pair are flanked by prominent chimneys, there is also a central chimney where the properties adjoin. The front roof slope has a full width flat roof dormers with small central pediments. The front elevation mirror in appearance, with full height canted bays with festoon decoration between floors. Moulded brick decoration to window and entrance surrounds. Entrances set to the side with segmental pediments and fanlight.

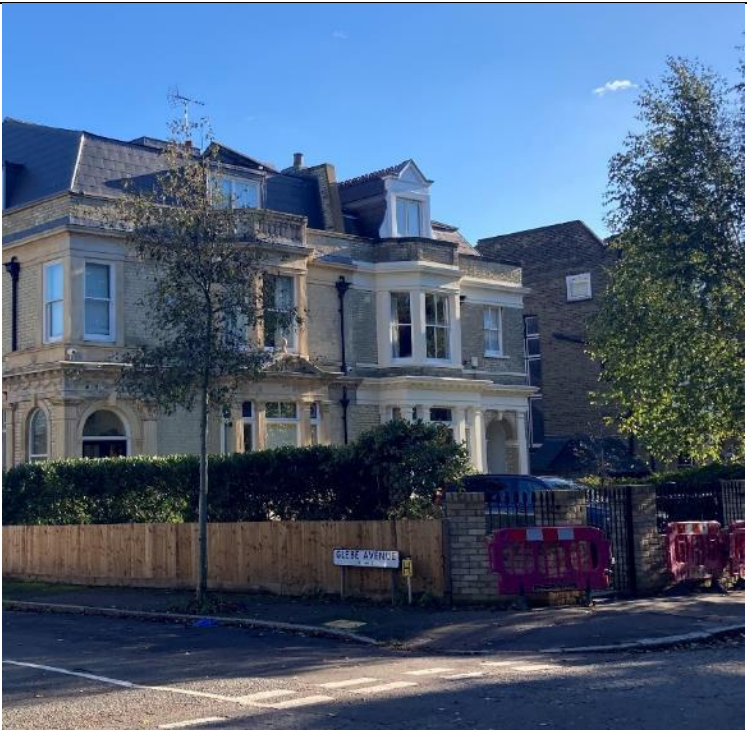
7. Description
Built circa 1895, the semi-detached property is two and a half storeys in height, constructed from buff stock brick. Stone window and entrance dressing, string course with dentil detail. Full height bay window to front elevation (square at ground floor and canted at first floor). Mansard to hipped roof in slate behind a parapet. Large, pedimented dormer window. Timber sash windows with central mullion. Cast iron rainwater goods with decorated hopped. Entrance set to the right accessed by steps and recessed behind storm porch with round arch flanked by pilasters.

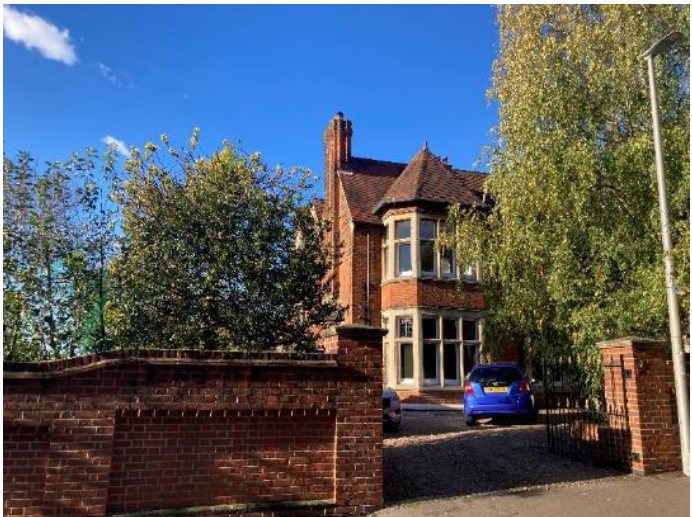
7. Description
1892, architect J.A. Gotch. Style Victorian 'Tudor'. Detached buildings of two storeys and attics, red brick with stone dressings and with tall, fluted chimney stacks with diagonally set brickwork. The south (main) elevation has a large gable and entrance doorway set in a wide stone arch approached by shallow stone steps. The eastern elevation has a massive square 'Tudor' stone bay to both floors, with leaded lights and some stained glass.

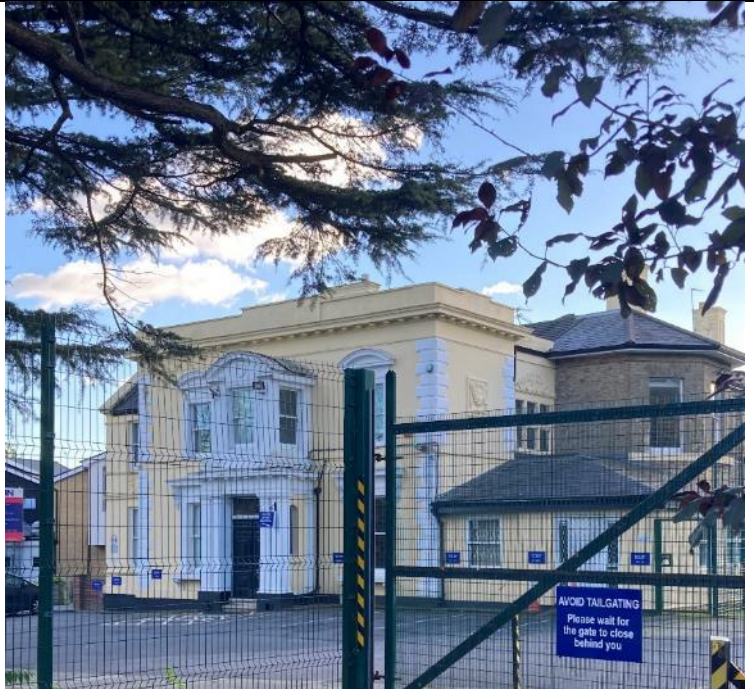
7. Description
Built circa mid-nineteenth century. This former country house originally known as Pymont House, is now a school which moved here in 1918. The original part of the building (north and some of the east parts) is a Stucco villa in the Italianate style, set over two storeys with inverted roof behind parapet. North elevation is three bays wide with a central entrance and portico doorcase with pediment to central first floor window. Eastern elevation has a gable projection and a single storey element. Building has with prominent chimneys. Long range to the rear (west) extension in yellow stock brick with a full height canted and low-pitched roof covered in slate, thought to date from 1927. Modern flat roof extension to southeast and infill extension.

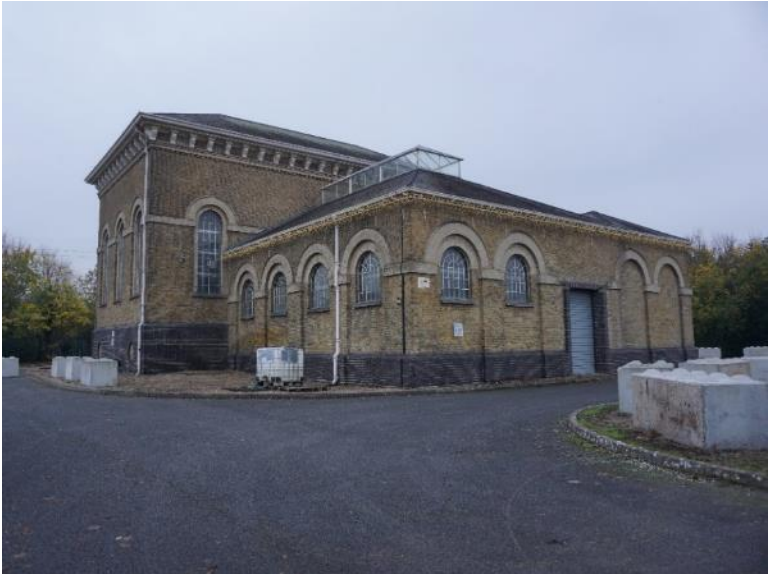
7. Description
 Built in 1904 and designed by Bernard W. Bryan, the building is a large rectangular engine house with projecting wing all on semi-basement. Lower fuel store/boiler house on east elevation. Constructed from yellow stock brick on projecting blue brick plinth. Low pitch hipped roof in graded Westmoreland slate on wide projecting eaves with large console brackets, grey brick string and dentil course. Moulded gutter forming cornice. Square cast iron rainwater pipes. Round headed windows with gauged brick arches in recessed surrounds. Projecting grey brick string courses at arch springing. Cast iron windows with glazing bars. Large door with semi-circular fanlight over and pair three panel doors in north elevation. The boiler chimney base remains with projecting brick quoins and recessed blind arches.

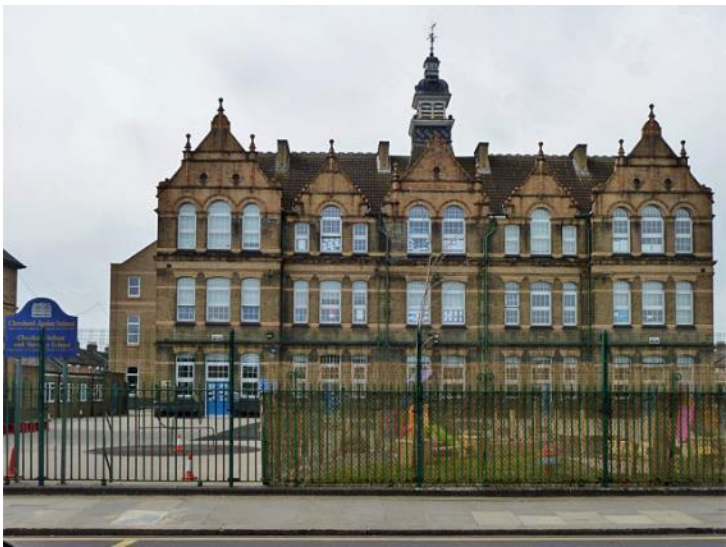
7. Description				
<p>Built 1895. Three storeys. Simple E-plan in five bays, the end bays projecting. Yellow stock brick with yellow Terracotta dressings. Dark tiled roof with ornamental belfry and weathervane. Flemish gables on east elevation. Hipped roof on west elevation with full height bay window. Double hung sash windows with glazing bars under segmental arches. Round arches in second storey gables. Original boundary railings on granite kerbs. Two storey school keeper's house in similar style.</p>

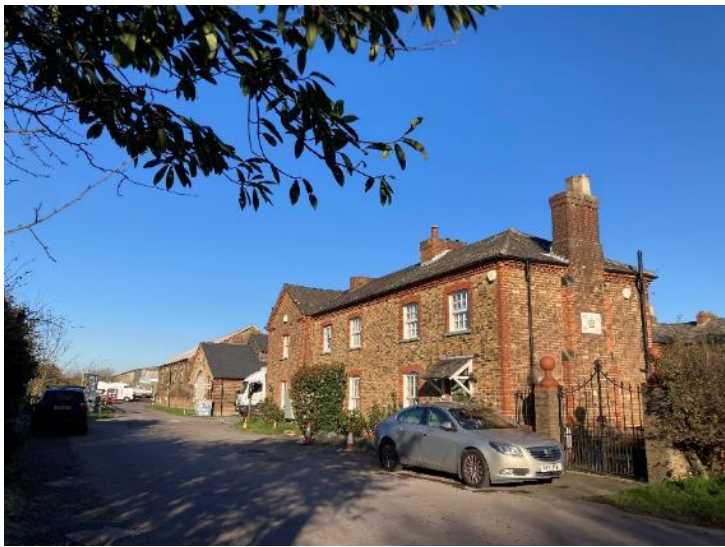
7. Description				
1855/57. Large complex of cottages and barns built by Crown Estates. Two storeys. Yellow stocks, low pitch slate roof. Wall Plaque with VR (Victoria Royal) in upper left corner, AR (Albert Royal) in upper right corner, crown in centre and date 1855.

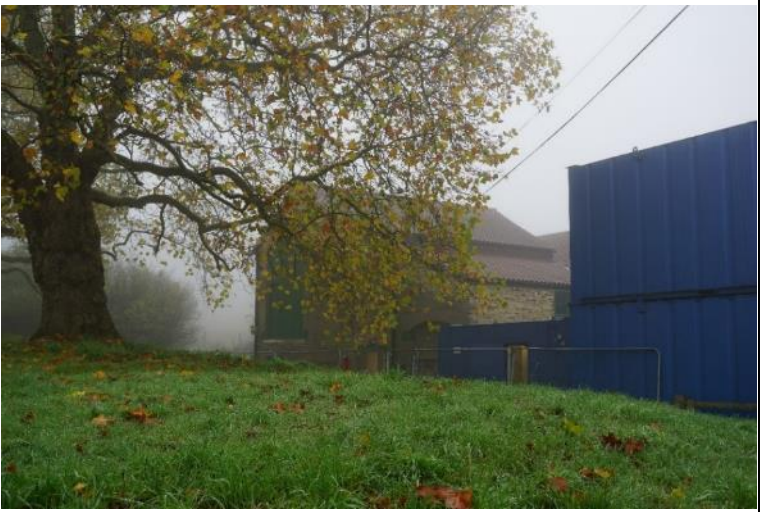
7. Description
A small group of mid-nineteenth century barns. They are constructed from brown stock brick with -pantile roofs. The barns have red brick semi-circular arched window openings some with timber louvres and dog toothed corbelled eaves.

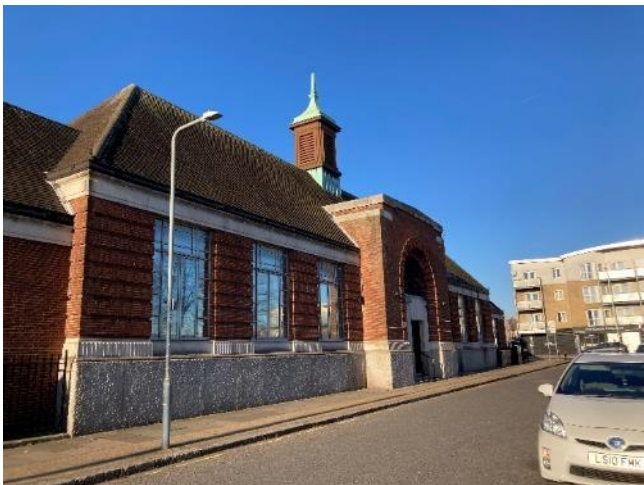
7. Description				
<p>Built circa 1937, the County Court is constructed in an Art Deco style. Constructed from red brick laid in Flemish bond set on a rough cast concrete plinth, under a plain tiled hipped roof with central louvered cupola. The principal elevation faces east with L-shape wing extensions set down from the central range. Portland stone detail to cornice, above plinth and door surrounds with geometric keystones. Projecting central entrance with deep recessed soffit. Large semi-circular arch with brick blockwork rustication. Metal railings to boundary with brick piers with concrete plinth and finial cap</p>

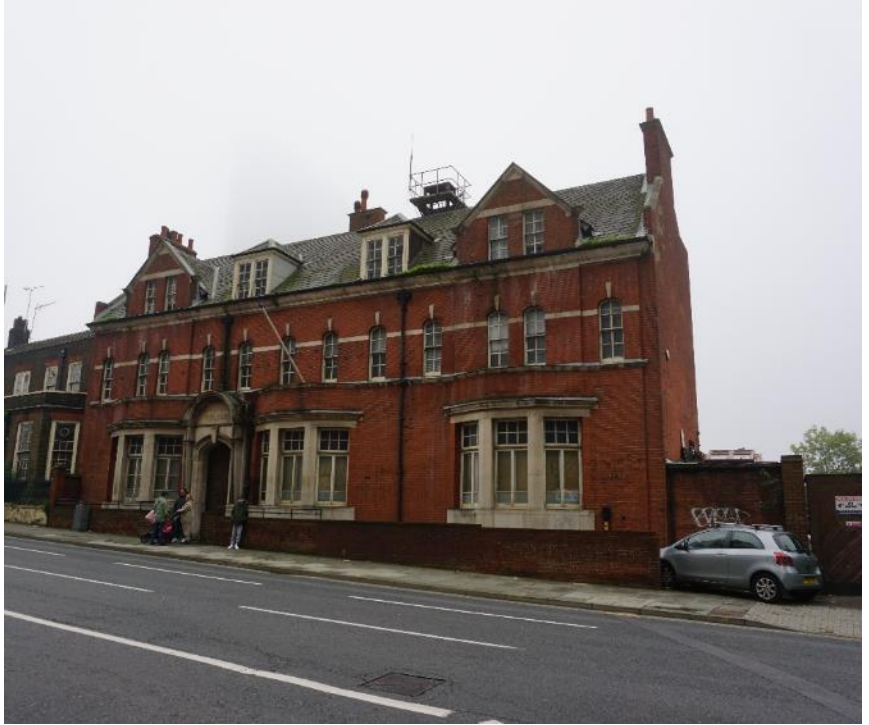
7. Description			
<p>Constructed in 1906 and designed by John Dixon Butler. Neo-Georgian two storey building with attic. Red brick with stone dressings. Medium pitch graded slate gabled roof with four dormers, two gabled and two hipped. First floor has twelve narrow windows under segmental arches and stone keystones. Entrance with semi-circular arched hood on tall Art Nouveau consoles. Flanking canted bay windows on ground floor. Third bay on right hand. Windows double hung sashes with glazing bars.</p>

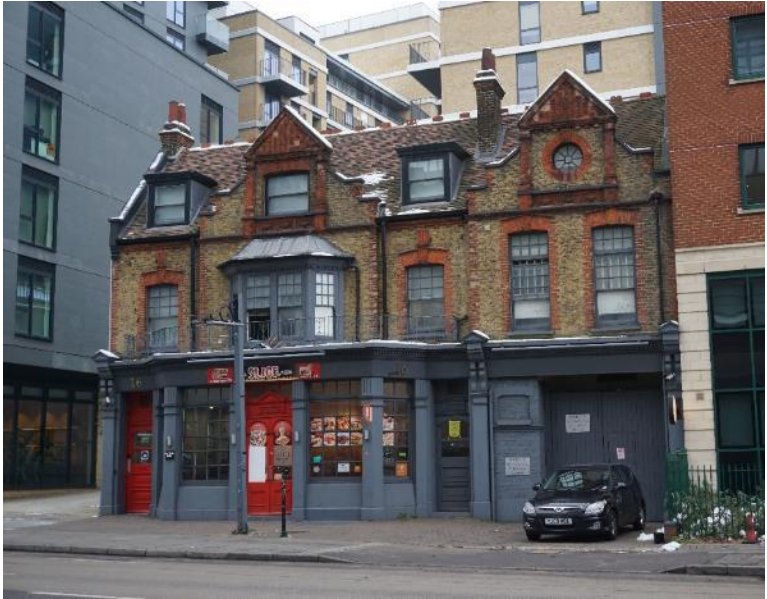
7. Description
 Early twentieth in architectural style with possible earlier origins. Former public house constructed from stock brick with red brick window dressing, quoining and dentil eaves. Parapet Dutch gables with terracotta decorative tiles, oculus window to righthand gable. Ground floor has a projecting canted bay with a central entrance, the bay is flanked by entrance doors, service entrance to the righthand side.

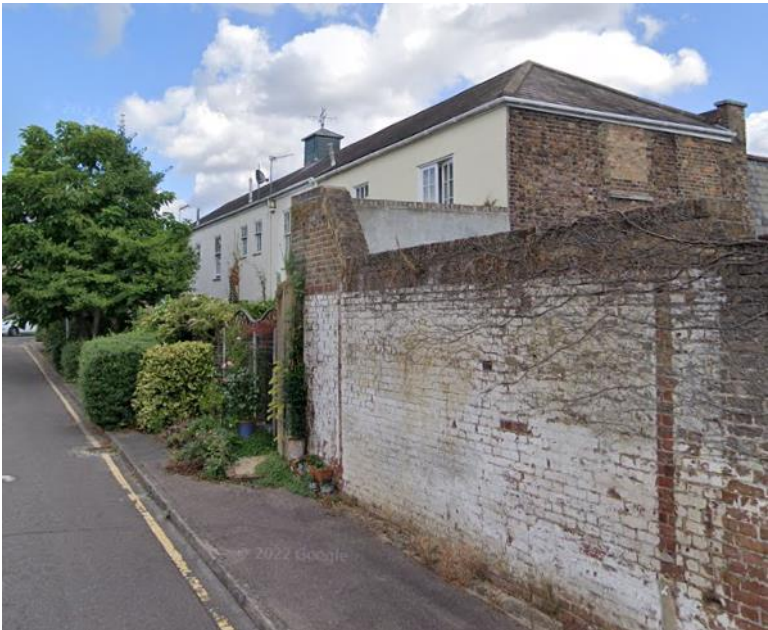
7. Description
<p>Early nineteenth century, former stable block constructed in light brick with a C-shaped planform. Now converted to residential units. The main block set on a north south axis is two storeys in height under a hipped slate roof; first floor windows are set in recessed semi-circular panels. The wing extensions (east west axis) are one and a half storeys under a mansard roof with sash windows. To the ground floor are seven entrance doors to residential units under small canopies.</p>

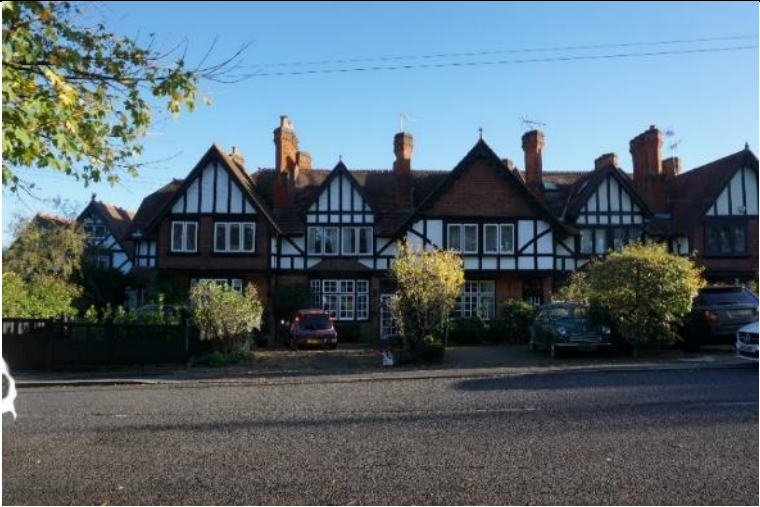
7. Description				
<p>Built circa 1870-90, a terrace of five model cottages with a detached dwelling each end. Set over two-storeys, ground floor is of red brick and upper floors with half timbering effect as well as scalloped and straight hanging tiles with decorative bargeboards. Terrace has half hipped ends with gabled front and rear projections, detached dwellings are of a gable form; all with plain clay tiles. All properties have tall, angled chimneys. Some with original timber casements with diamond leaded lights and some replaced by plain glazing.</p>

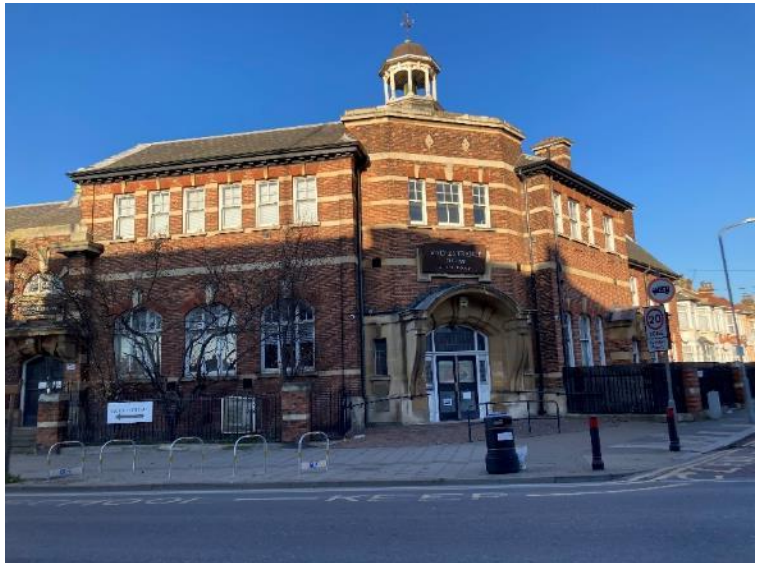
7. Description
Built 1908 by Henry Shaw. A Carnegie Library. Altered 1968. Library is two storeys. Public Hall one storey and basement. Red brick with cream stone dressings. Slate roof with dentils at eaves. Canted corner entrance with moulded stone canopy on large projecting curved stone brackets. Plaque over inscribed 'Carnegie Public Library'. Crowning parapet and cupola. Recessed arched entrance with flat moulded stone canopy to Public Hall. Library interior has numerous freestanding Corinthian columns and staircase with decorative balustrade. Public Hall interior has shallow barrel vaulted ceiling. Curved fronted rear balcony on deep decorative brackets. Interiors of both are not of special interest. Library lodge. Two storeys. Three storeys. Three windows with ground floor projecting splayed bay. Modest house of group value only.
